# **Fire Safety in High-rise Buildings, Lessons Learned from the WTC**

## **Abstract**

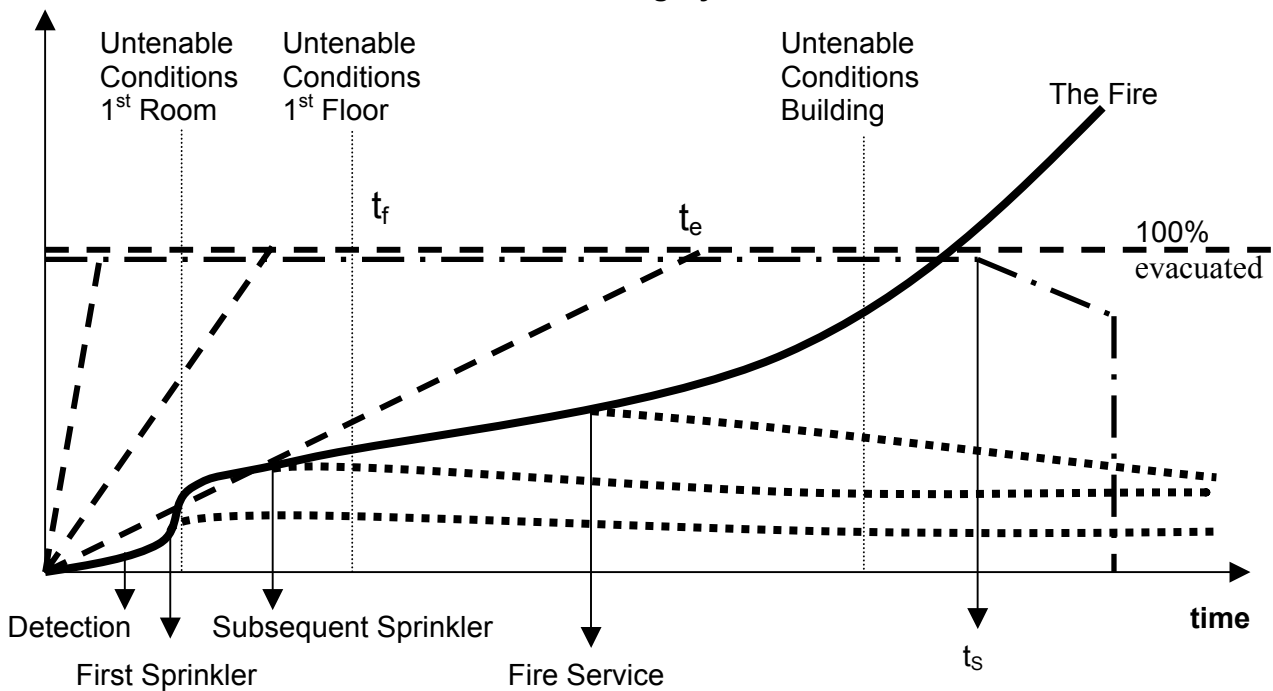
**Figure 1** Schematic of the sequence of events following the onset of a fire in a multiple story building. The thick line corresponds to the “fire size,” the dotted lines to the possible outcome of the different forms of intervention (sprinkler activation, fire service). The dashed lines are the percentage of people evacuated, with the ultimate goal of 100% represented by a horizontal dashed line. The dashed & dotted line corresponds to the percentage of the full structural integrity of the building.

The schematic presented in Figure 1 could represent the behavior of a building in the event of a fire. It could be argued that the safety objective should be that the time to evacuation ( $t_e$ ) at each compartment (i.e. room of origin, floor, building) be much smaller that time necessary to reach untenable conditions in the particular compartment ( $t_f$ ). Characteristic values of  $t_e$  and  $t_f$  can be established for different levels of containment, room of origin, floor,

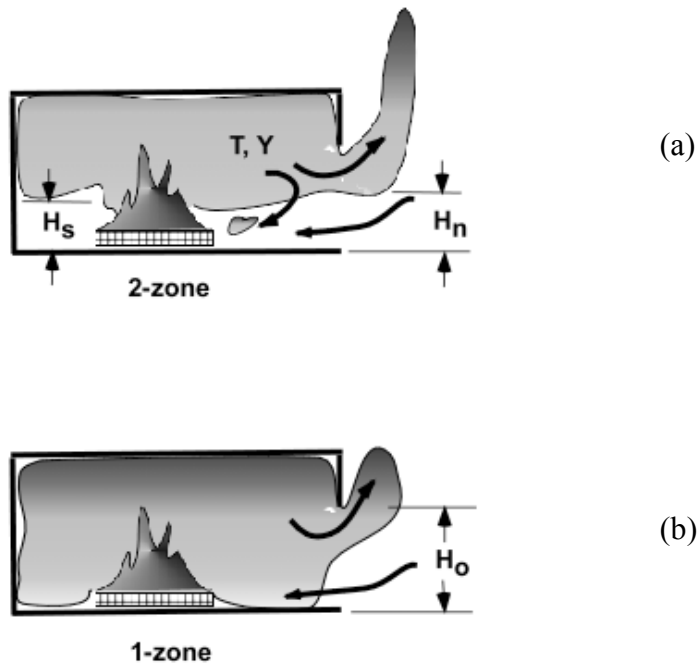
**Figure 2** Stages of fire growth (a) growth period represented by a two zone model (b) fully developed fire represented by a single zone model

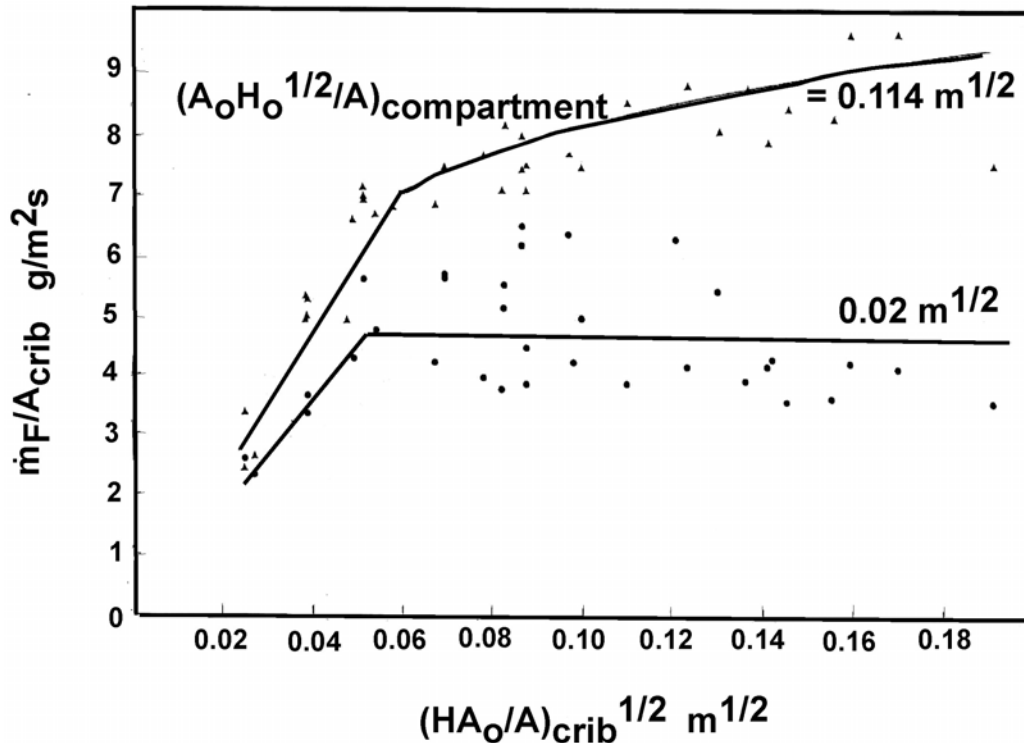
**Figure 3** Wood crib burning behavior in a compartment based on the total crib surface area, from Thomas and Nilsson [5].

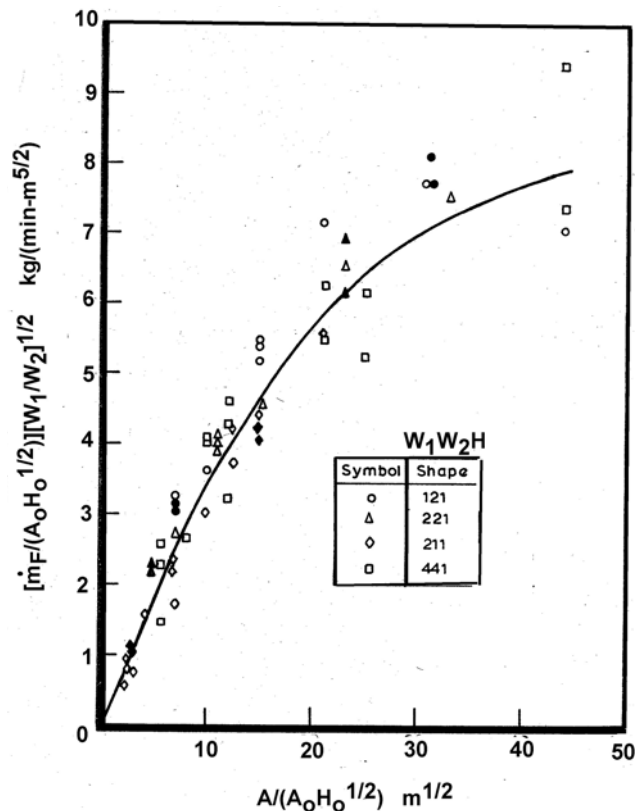
**Figure 4** Wood crib burning rate in the CIB study.

The aspect ratios of the floors in the World Trade Center would have lead rapidly to a ventilation-limited state. In this particular condition the burning rate of fuel could have been expected to attain an asymptotic steady-state value rapidly. Figure 3 shows a plot of the asymptotic burning rates for ventilation

limited wood crib fires. As can be noted, the burning rate is strictly dependent on the incoming air or ventilation factor. It is important to note that these empirical relationships between the burning rate and the ventilation can be supported by simple analytical expressions allowing for the calculation of the conditions within the compartment.

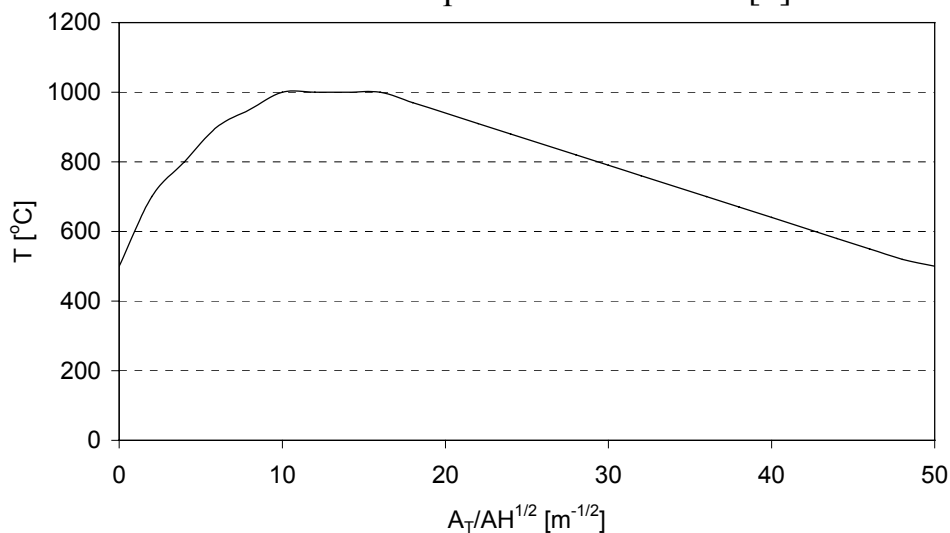
**Figure 5** Time mean temperature near the ceiling. Where  $A_T$  is the total area excluding floor an opening, a the window area and  $H$  the height of the window. The fuel loads for these tests are in the range 20-40 kg/m<sup>2</sup> that is smaller but nevertheless comparable to what would be expected in a modern office.

Except for scale effects, there is no reason to believe that the temperatures inside the floor of the WTC fires would be bigger than those given by Figure 5. The only area where temperatures could be expected to be slightly higher is the area close to the windows where flames projected through openings have been found to reach up to 1200 °C [13]. But limited flaming is seen from the WTC windows from available videos. To date there has been no systematic archiving or review of the video records of this event. Indeed some footage may have been suppressed.

Here it is of importance to add that the outcome of this event should serve to encourage us to question the completeness of Figure 5. The analysis of the previous section raises the question of how applicable this data could be to a scenario such as the World Trade Center, the outcome validates this question and pushes us to insist that further research should be conducted.

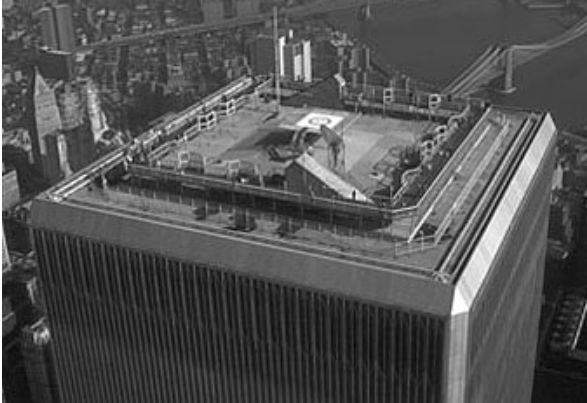
Figure 6 Isometric View of WTC [15]

The plan area of the two main towers of the building complex formerly known as the World Trade Center in New York was quadratic (Figure 6) with each side measuring 63.5 meters in length. Each of these towers was 411 meters high and contained 110 stories.

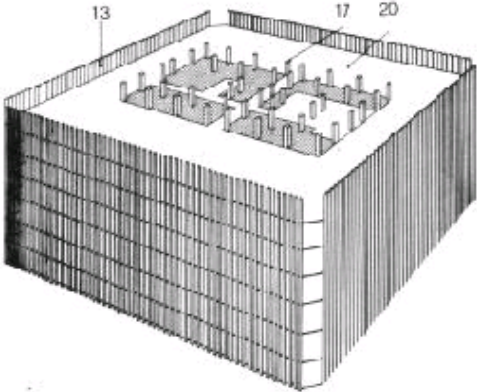
Figure 7 Isometric View of Building [16]

- 13 – Perimeter frame
- 17 – Core box columns
- 20 – Floor

Their uniqueness within the skyline of New York was not only an optical but also a technological one. The applied tube construction (Figure 7) is a structural form of construction that is optimal for very tall buildings. It provides the required strength and stiffness by utilizing:

- A rigid perimeter frame (framed tube) to carry all wind loads and resist all overturning forces, and
- A coaxial running central core that took solely the gravity loads of the building.

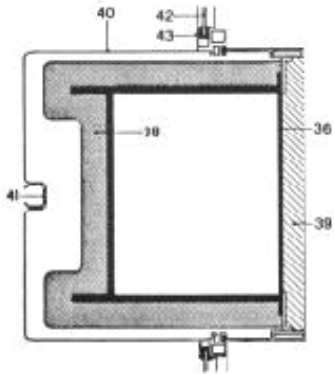
**Figure 8** Exterior Box Column [16]

36 – Steel column  
38, 39 – Fire resistant plaster

Each of the four 63.5 meters long sides of the plan area quadrate, that formed the perimeter frame, consisted of 59 Exterior Box Columns (Figure 8) that were spaced on approx. 1 meter center and interconnected. Window glazing 0.56 m was between each exterior column, and framed by aluminum alloy-sheathed piers each 0.48 m wide (“Sometime Lofty Towers”). Each of the four sides of the perimeter frame were interconnected with their perpendicular standing counters sides forming, together with the floors, a momentum rigid framed tube that was fixed to the foundation.

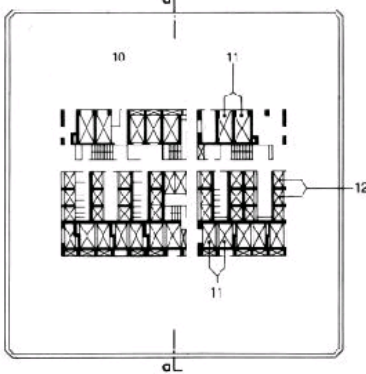
**Figure 9** Plan View of Typical Floor [16]

11, 12 – Lifts  
10 – Open plan offices

The central core (Figure 9) ran coaxial within the frame tube and spanned over a rectangular area of 24 by 42 meters. The core contained 44 Core Box

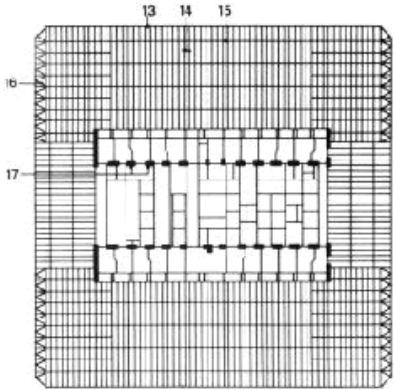
**Figure 10** Structural System for Typical Floor [16]

13 – Perimeter frame  
14 – Bar joists  
15 – Secondary joists  
16 – Horizontal floor bracing  
17 – Core box columns

In between the perimeter frame and the central core the floor, constructed of prefabricated trussed steel (900 mm deep bar joists), spanned over the full 18.3 meters, braced by secondary joists (Figure 10). These joists acted as a diaphragm to stiffen the outside wall against lateral buckling forces. The secondary joists supported a profiled deck on which a 100 mm thick light-weight concrete was poured.

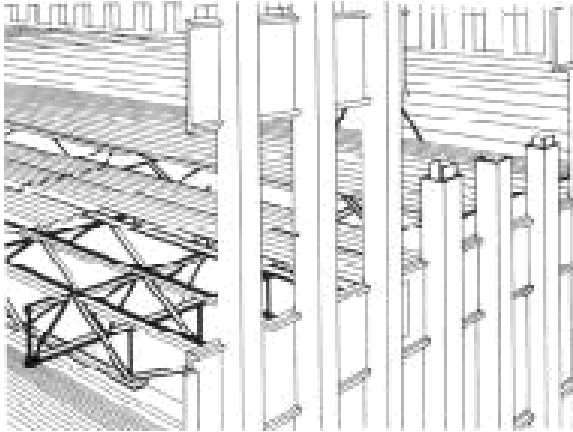
**Figure 11** Isometric View of Floor and Exterior Wall System [17]

Figure 11 and Figure 12 give an additional insight in respect to how the structure of the two main towers of the World Trade Center was constructed. The floor-truss system was not supported by the columns directly, but was connected by bolts and welded flange connectors to the columns. These connections would only be able to support the combined load of several floors. They may have been the weakest link in the progressive collapse that occurred.

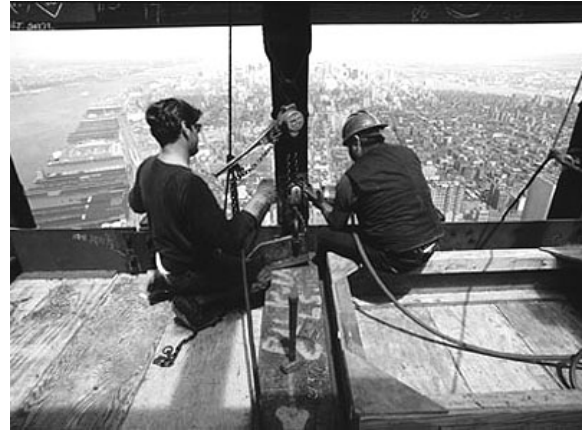
**Figure 12** View of Floor and Exterior Wall System from within the building [15]

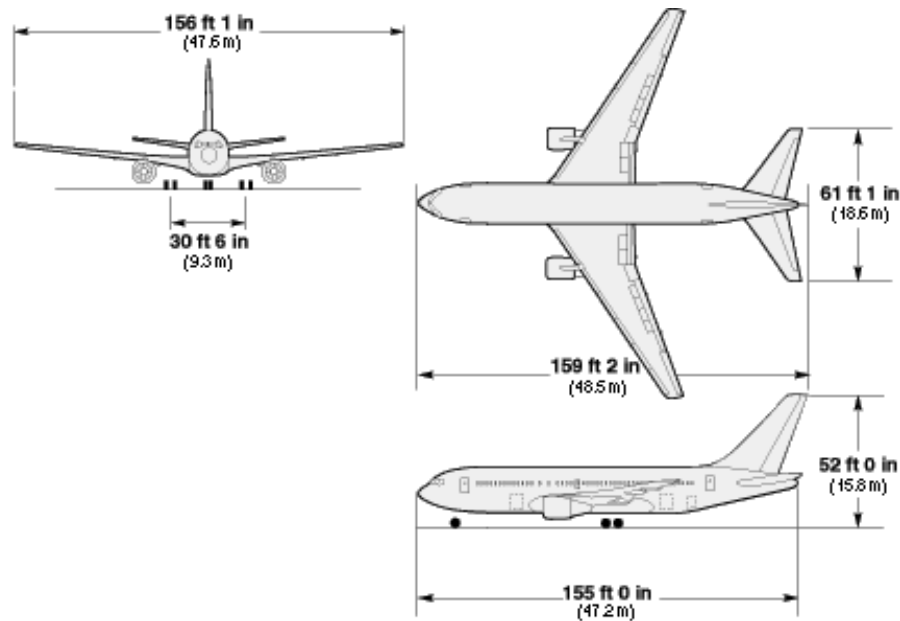
**Figure 13** Basic dimensions of a Boeing 767-200 [18]

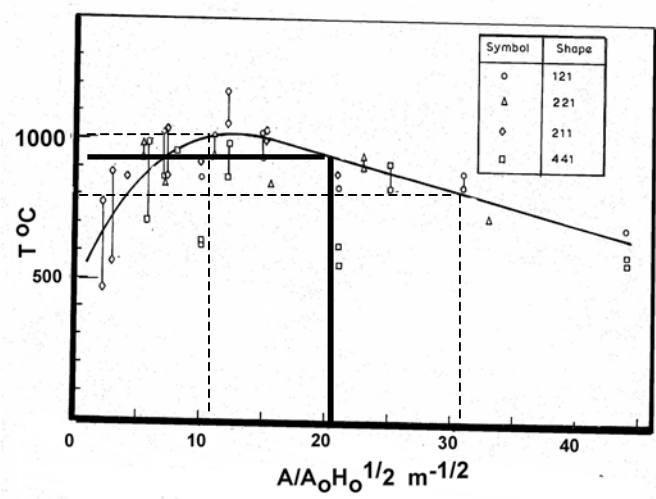
Figure 15 Temperature from CIB [5].

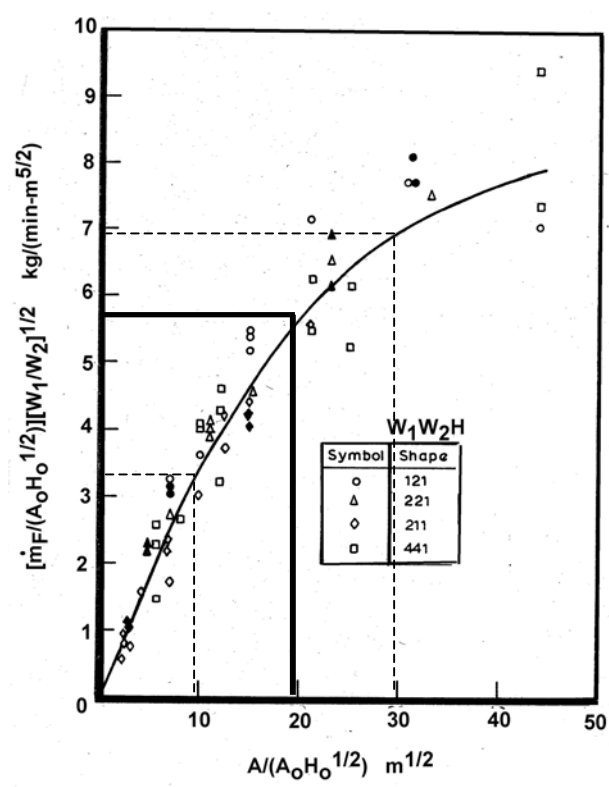
Figure 16 Burning Rate form CIB [5]

Using a 50 % variance, this gives a range on the CIB correlations in Figure 16 and Figure 17. Note that Figure 16 and Figure 17 were previously presented as part of the background. The results indicate temperatures of 800 to 1000 °C, and a burning rate of about 15 to 30 kg/s. As mentioned before, it is quite possible that the temperature could have exceeded those values estimated here.

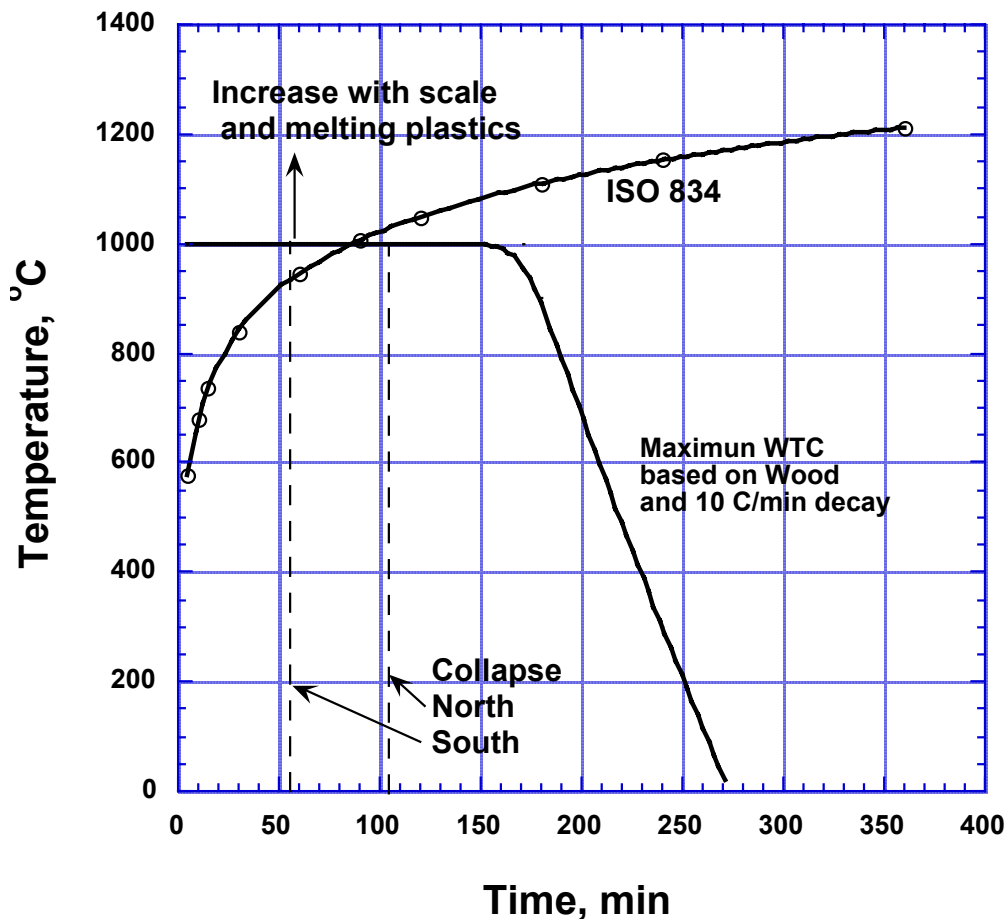
Figure 17 shows the estimated maximum temperature in the WTC office floors in comparison with the ISO 834 temperature curve. From the collapse times, the temperatures corresponding to the test are within the error of those estimated. It can be therefore argued that protection on the steel members was not adequate. The uncertainty, nevertheless, can go both ways, since the temperature could have been well in excess of ISO 834 or the values predicted here, or the uncertainty can be related to lack (or poor) of insulation due to the impact or original state of the protection. The actual state of the fire proofing at the time of impact is not known.

Figure 17 Estimation of WTC floor temperatures and ISO 834.
