Reference: Gales, J., Bisby, L.A., and Gillie, M (2011) Unbonded Post Tensioned Concrete in Fire: A Review of Data from Furnace Tests and Real Fires. Fire Safety Journal. 46:151-163.

Unbonded Post Tensioned Concrete in Fire: A Review of Data from Furnace Tests and Real Fires

Key words: Prestressing steel; Post-tensioned slabs; Unbonded construction; Fire endurance testing; Spalling; Concrete; Concrete cover; Case studies.

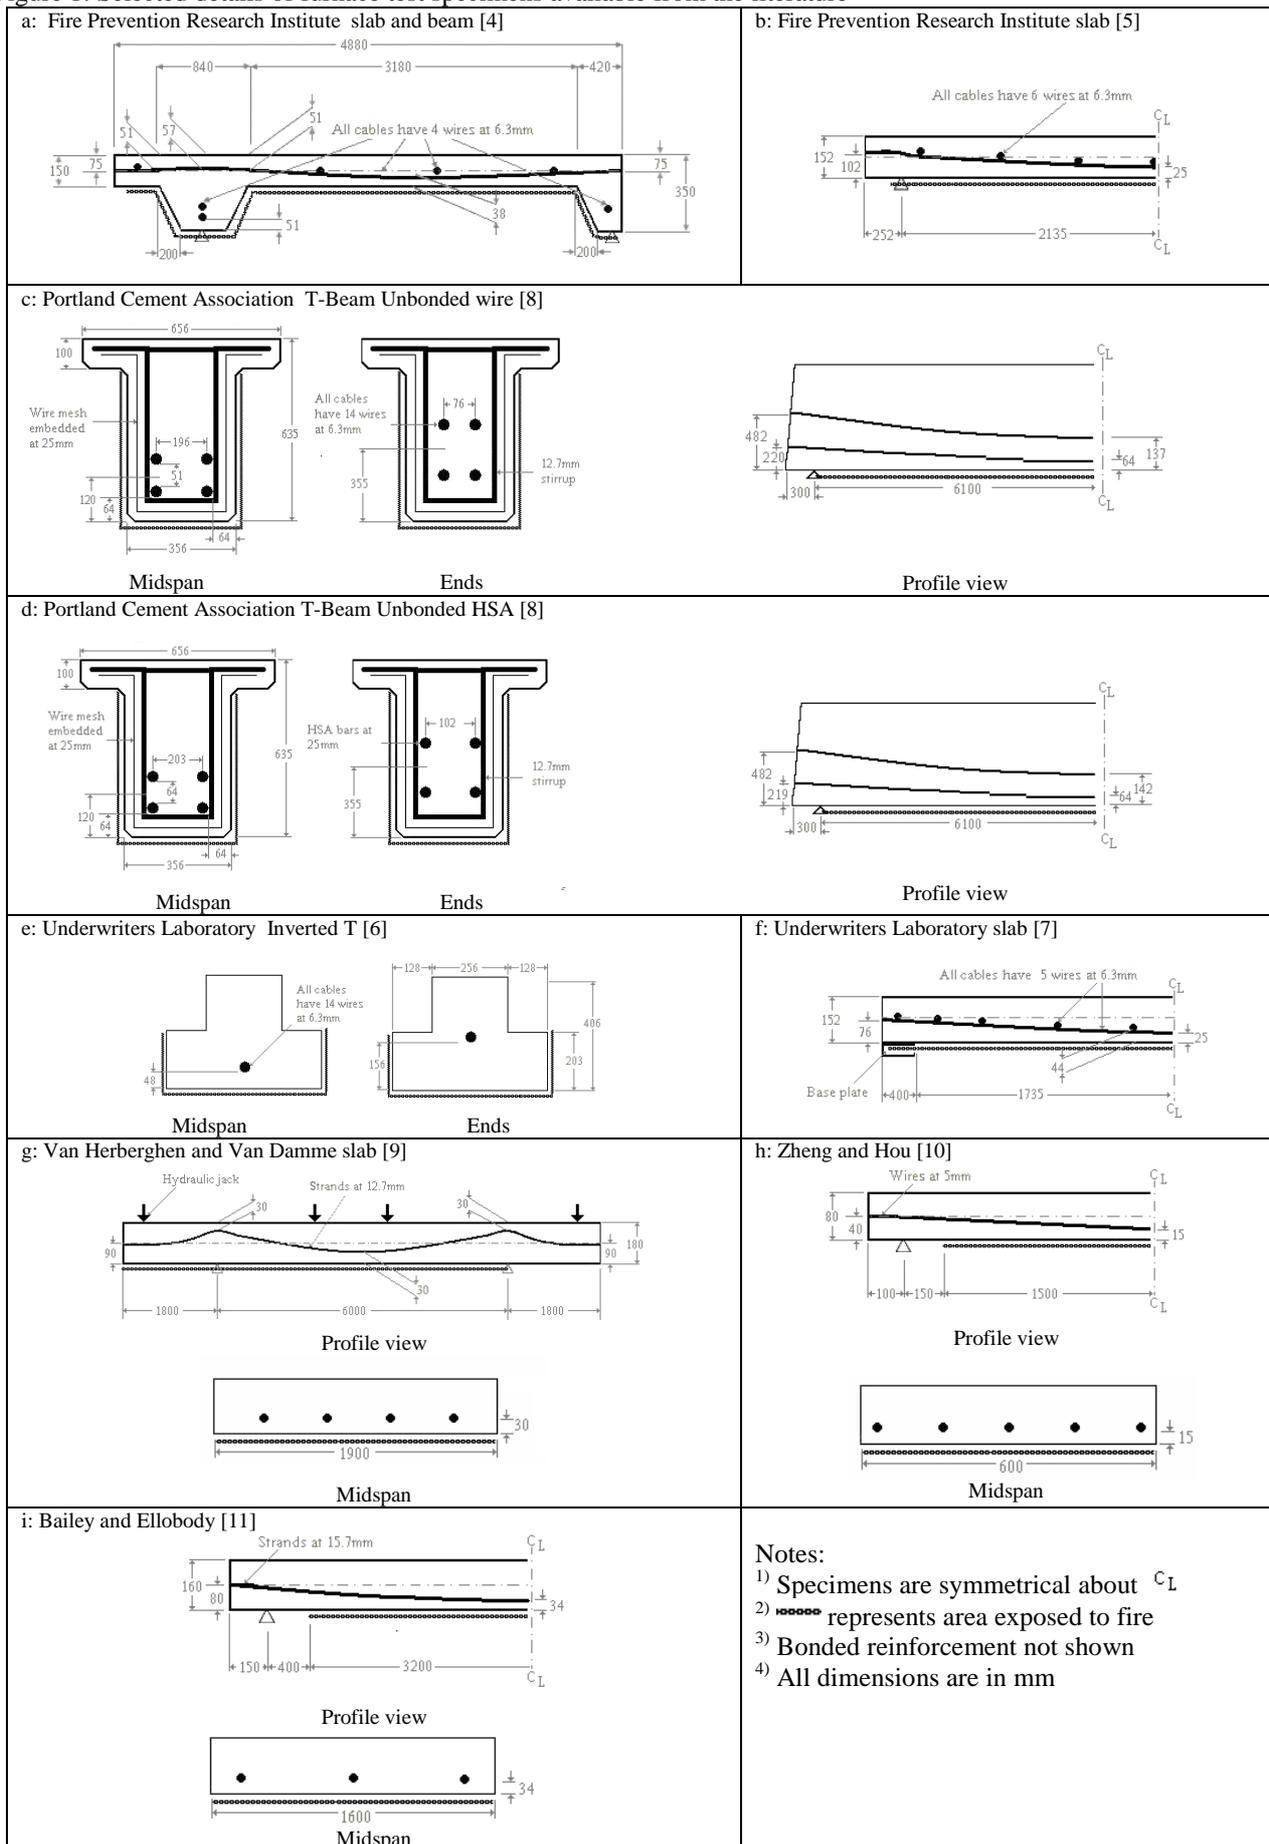
Figure 1: Selected details of furnace test specimens available from the literature

In 1967, UL conducted a single standard fire test of a two-way UPT slab panel cast from lightweight concrete [7, 41, 42]. Figure 1f shows the tested assembly, which consisted of a 152 mm deep, expanded shale aggregate concrete slab panel spanning 4270 mm by 5380 mm supported on steel bearing plates at its corners. The slab was prestressed with draped UPT cables in both directions. The minimum clear concrete cover to the UPT cables, each of which consisted of five 6.3 mm diameter cold drawn, high tension stress-relieved wires, each having a minimum guaranteed ultimate tensile strength of 1655 MPa, was 25 mm in the larger spanning direction. The tendons were prestressed to achieve an in-service design stress of 992 MPa, once the superimposed load had been applied for the fire test. No mild steel reinforcement was provided within the spans. The assembly was subjected to a uniformly distributed superimposed load of 1.0 times the design live load, and was tested under an E119 [35] fire using a “fully restrained” condition in both directions (using similar methods as in the FPRI tests described previously). The concrete compressive strength at the time of testing is not known, although it was only 29 MPa at 28 days.

Details of a typical specimen tested by Van Herberghen and Van Damme [9] are shown in Figure 1g. Also shown is a schematic of the test setup, support and loading conditions, and fire exposure. The eight one-way slab strips were 180 mm thick by 1900 mm wide, and approximately 9000 mm in total length. Longitudinally they all had draped 12.7 mm nominal diameter longitudinal seven-wire prestressing tendons, with 1150 MPa initial prestress levels, and all were continuous over two internal supports with a central span of about 6000 mm and cantilever spans at each end. Only the central span and one cantilever were exposed to fire. Several parameters were varied amongst the specimens:

The slabs were loaded during testing using four hydraulic jacks (as shown in Figure 1g) to produce “a condition of zero rotation at the supports.” Exactly how and why this loading condition was chosen is unclear. As a consequence of this rather unusual support condition, the applied load (and hence the bending moments at the critical sections) varied throughout the tests – it seems unlikely that this was any more representative of full-structure response in a real fire than a restrained standard fire test on an isolated structural element with constant vertical load. The initial load was chosen to simulate a comparatively high uniformly distributed superimposed live load of 4.9 kPa. In the paper describing these tests, Van Herberghen and Van Damme [9] comment that “the importance of the initial bending moments was of minor influence on the ultimate fire resistance.” It is not clear exactly what is meant by this, but it appears from the data presented that the evolution of bending moments during the fire exposure was far more important in governing the slabs’ collapse than the initial loading condition. This is of considerable interest, since the initial load ratio is universally assumed to be of central importance to the structural fire resistance of a flexural assembly in a standard furnace test – to the extent that larger fire endurance are assigned to assemblies with lower load ratios for some types of construction [42, 45]. This confirms the increasingly widespread notion that full-structure interactions in fire are likely to be more significant than the capacities of isolated members as demonstrated through standard furnace tests.

Zheng and Hou [10] report on nine standard furnace tests on small-scale (model), one-way spanning UPT slab strips prestressed with steel wires. Figure 1h provides details of a typical tested assembly. All specimens were fabricated from carbonate aggregate concrete with a width of 600 mm and spanning 3300 mm between simple supports. The prestressing consisted of between two and five prestressing wires, each with a diameter of 5 mm and an ultimate tensile strength of 1722 MPa. The wires were prestressed to between 655 MPa and 1022 MPa prior to testing. A clear concrete cover of 15 mm, 25 mm, or 30 mm to the prestressed reinforcement was provided for the 80, 90, and 95 mm thick slabs, respectively. Varying amounts of mild steel longitudinal reinforcement were provided within each of the slabs; the mild steel longitudinal reinforcement ratio varied between 0.20% and 0.45%. All slabs had mild steel transverse reinforcement with the same clear cover as the prestressed reinforcement at midspan, and with a reinforcement ratio of about 0.17% to 0.20% depending on their thickness.
